## **APPENDIX D**

### **Technical Scope of Work**

#### **Area of Investigation 1 - USOR Property**

#### **Remedial Investigation/Feasibility Study**

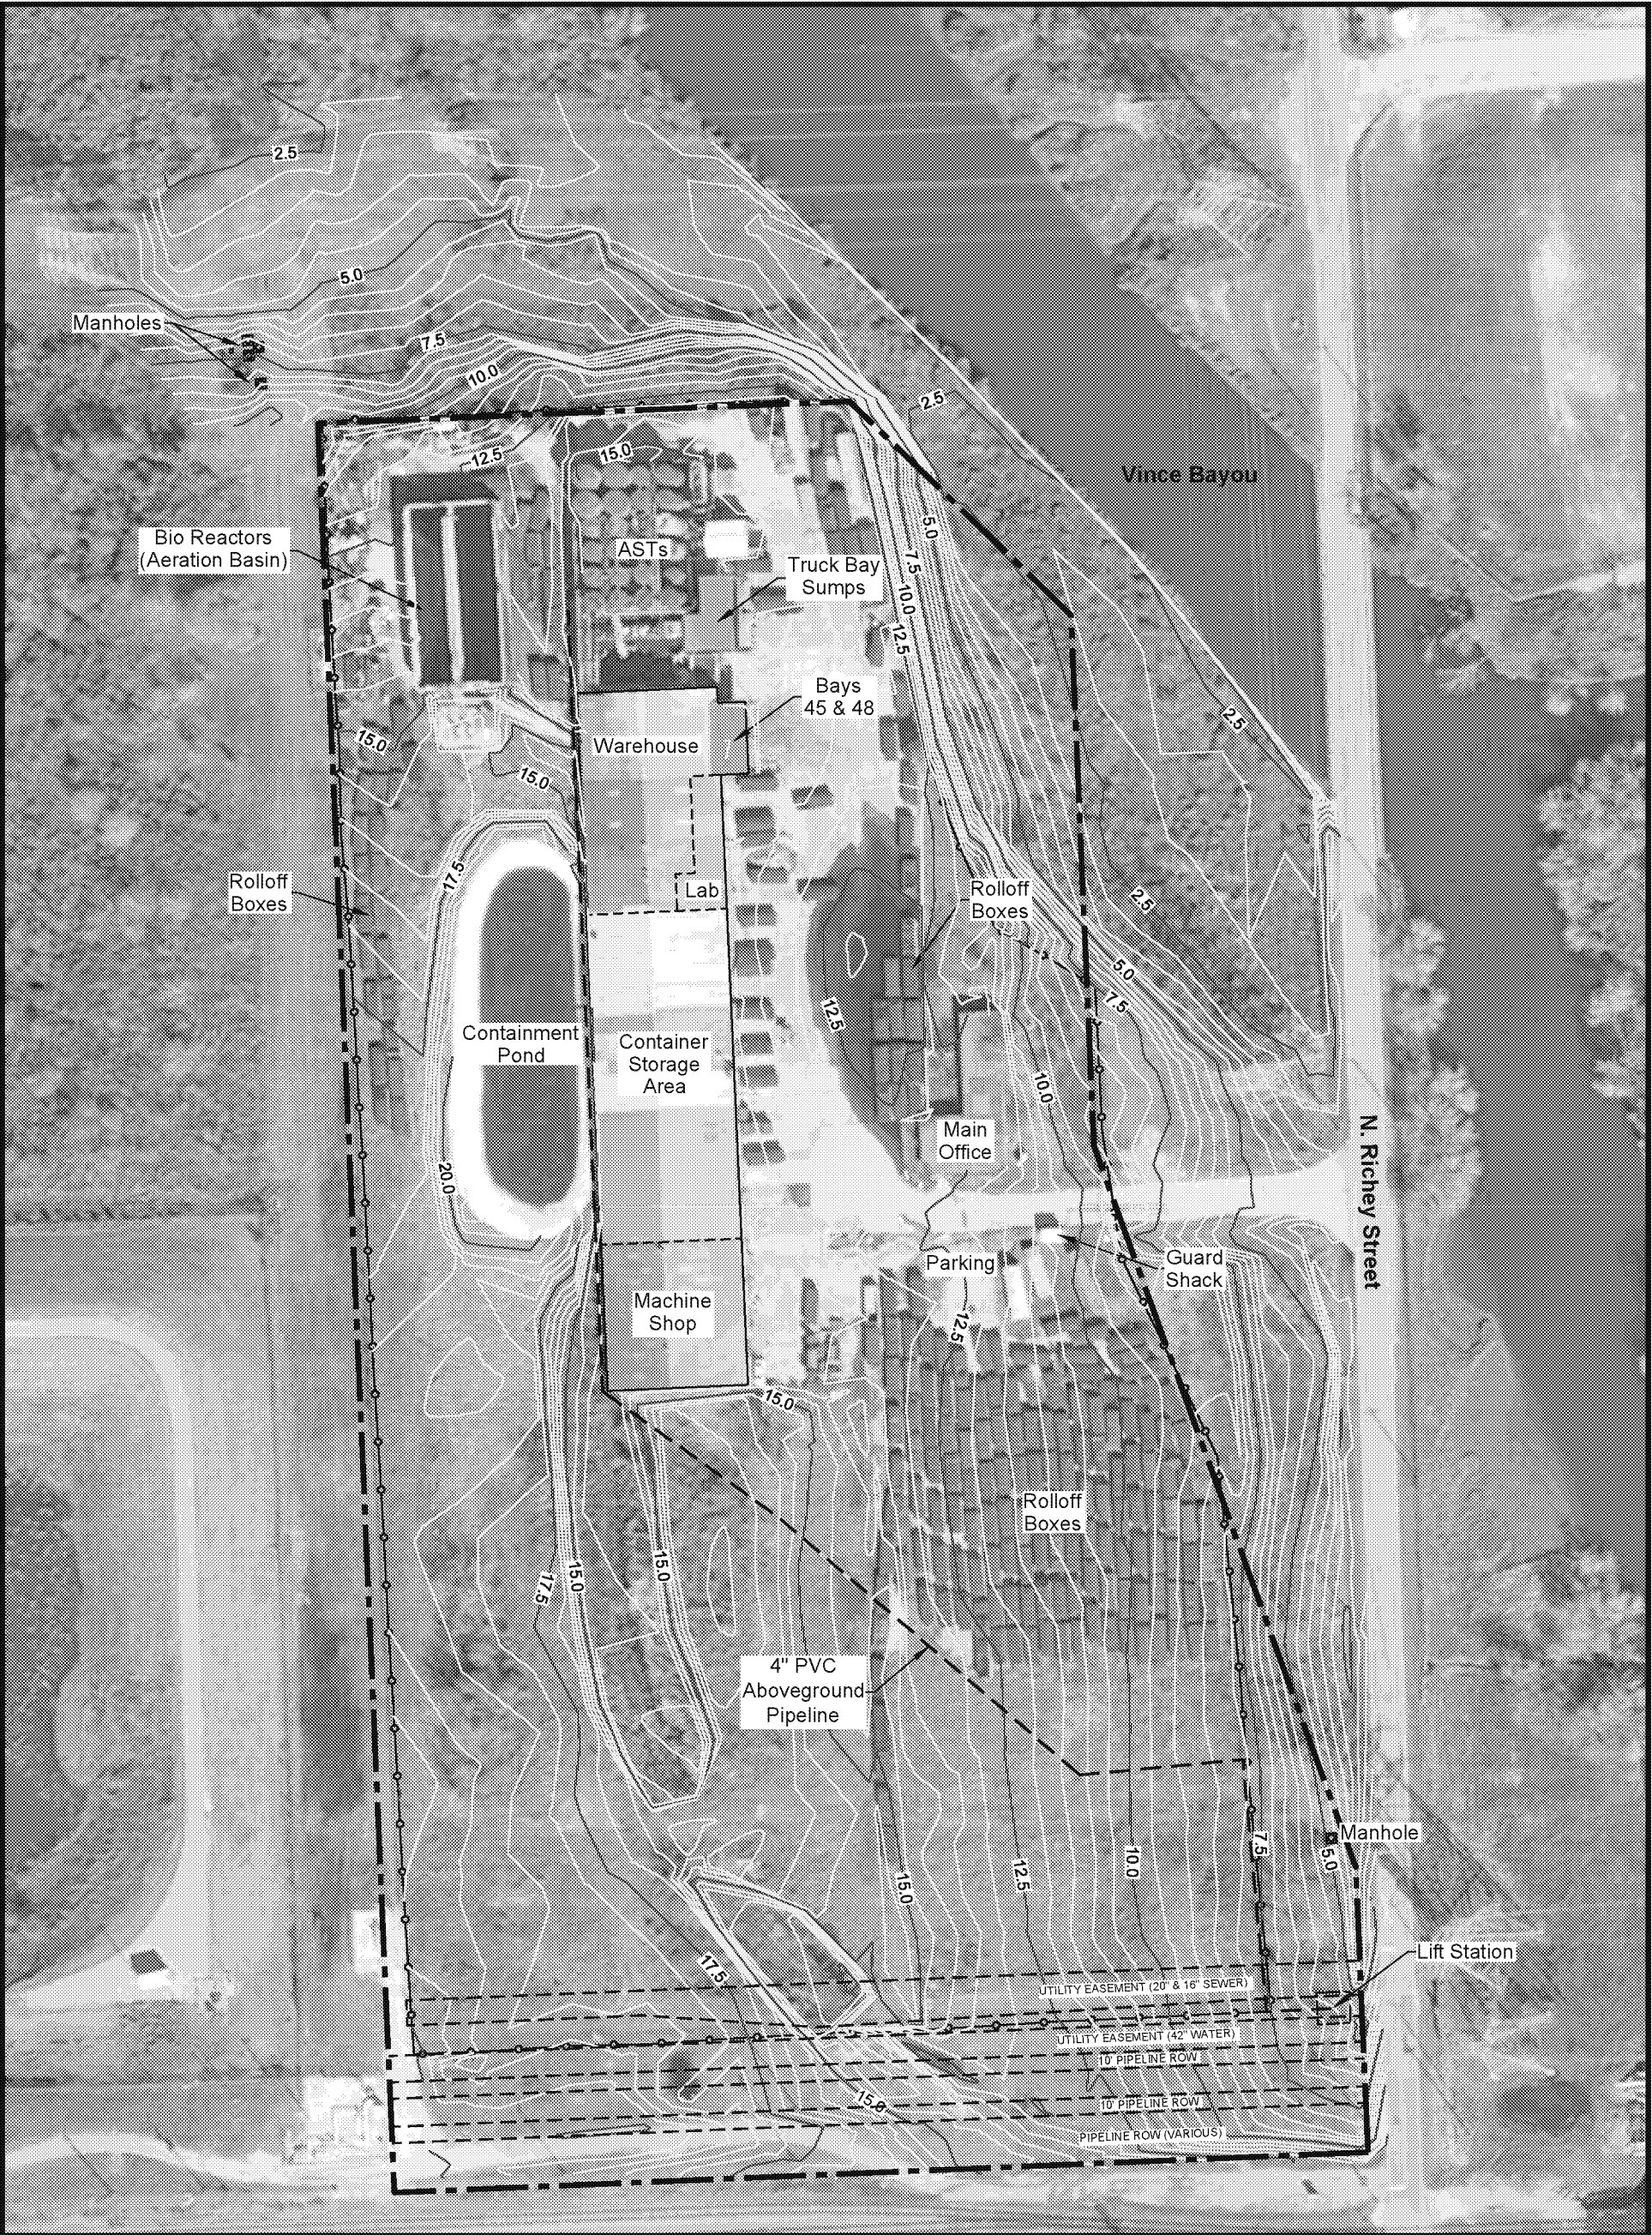
The USOR Property is located at 400 North Richey Street in Pasadena, Harris County, Texas, 77506 (Figure 3). The approximately 12.2 acre property was most recently used as a used oil processing and waste treatment facility by US Oil Recovery LP (USOR LP). USOR LP began operations on the property in approximately June 2003 and acquired the property in December 2003. Prior to 2004, multiple businesses operated on the property including chemical manufacturing companies (specializing in fertilizers and/or herbicides/pesticides), a cow hide exporter, leather tanner, and companies with unknown operations including storage of various hard goods. Attachment D-1 contains a more detailed listing of the operational history of the property.

- Approx. Property Boundary
- Approx. Security Fence

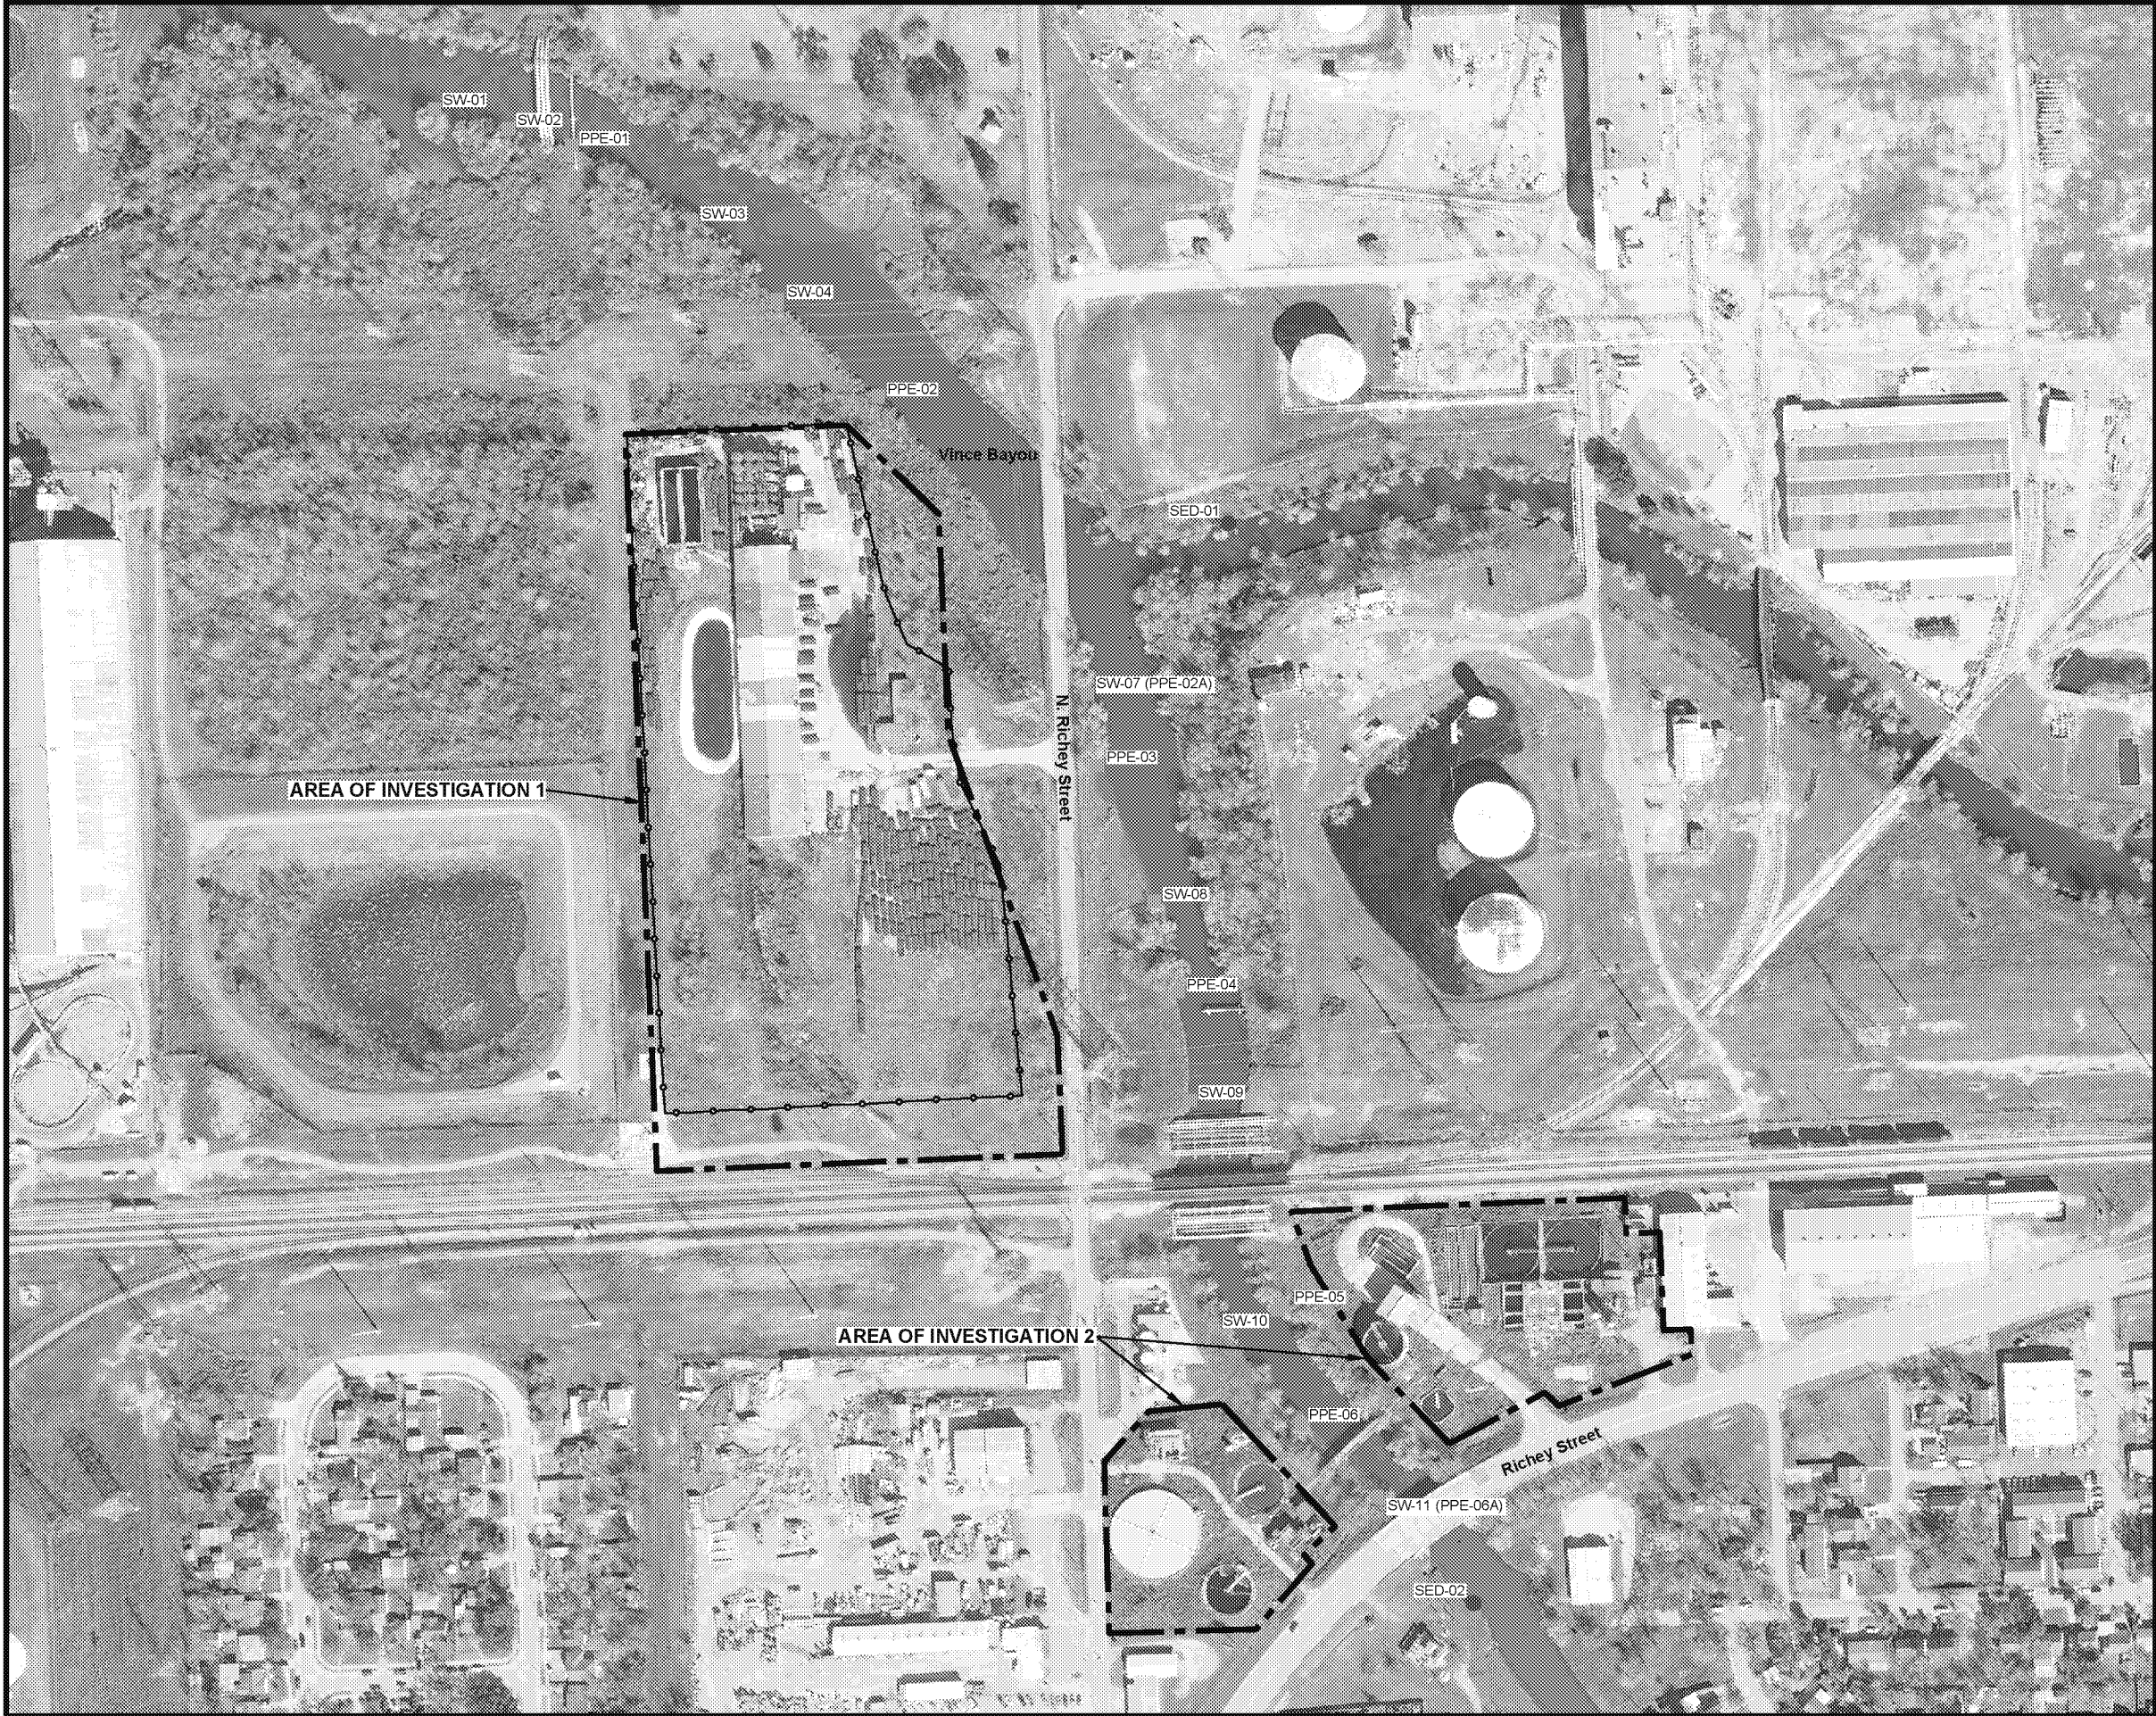
- Approx. Property Boundary
- Approx. Security Fence
- Approx. Surface Water and/or Sediment Sample Location (EPA, 2011)
- Approx. Background Surface Water and Sediment Sample Location

Samples of sediment will be collected from the two areas at the southwest portion of the USOR Property as noted on Figure 6. The samples will be analyzed for COPCs and other parameters such as TOC, grain size, etc. Sample collection methods will be described in the RI/FS Work Plan, FSP and QAPP.

Samples of surface water will be collected from the two areas at the southwest portion of AOI-1 as noted on Figure 6 (if present). The samples will be analyzed for COPCs. For the metals, analysis will be conducted for total and/or dissolved concentrations depending on the specific COPC (and as designated by the ecological benchmark table). Collection of samples from these areas depends on conditions during the investigation since these areas likely do not always contain standing water. Sample collection methods will be described in the RI/FS Work Plan.
